## PROPERTY CHECK

Sample report  
San Jose, CA 95123

Sample Team  
JANUARY 17, 2022

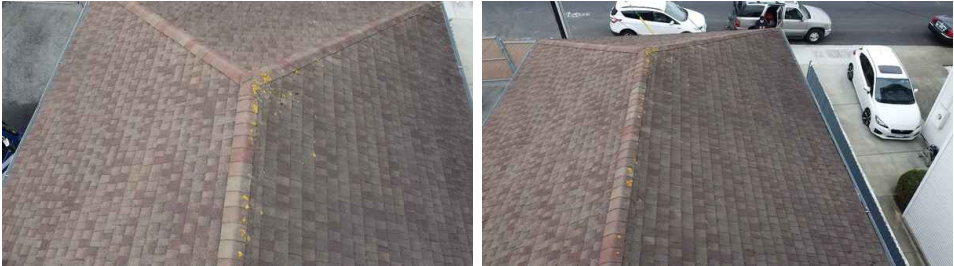
ALGEA OBSERVED ON THE ROOF

Recommendation

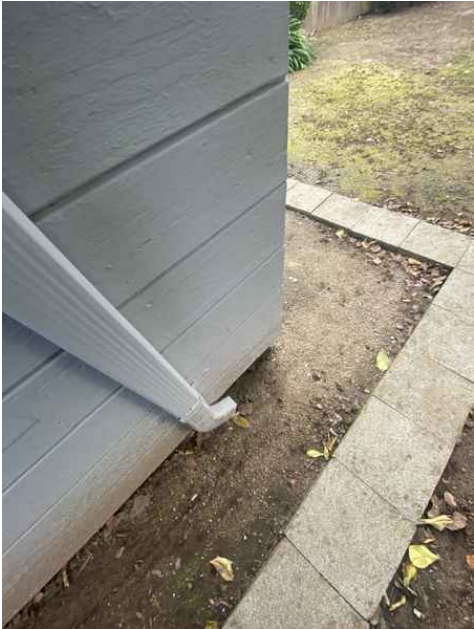
2.5.1 Gutters & Downspouts

DOWNSPOUTS DRAIN NEAR HOUSE

One or more downspouts drain too close to the home's foundation. This can result in excessive moisture in the soil at the foundation, which can lead to foundation/structural movement. Recommend a qualified contractor adjust downspout extensions to drain at least 6 feet from the foundation. A handy homeowner should be able to do this project.

Recommended DIY Project

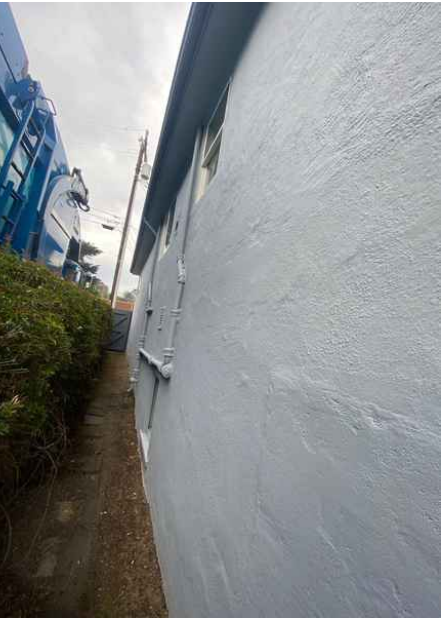
**Wall-Covering, Flashing & Trim:**  
**Type of Wall-Covering Material**  
**Described**  
Stucco  
Inspection satisfactory.

**Exterior Doors: Exterior Doors**  
**Inspected**  
I inspected the exterior doors.  
Inspection satisfactory.

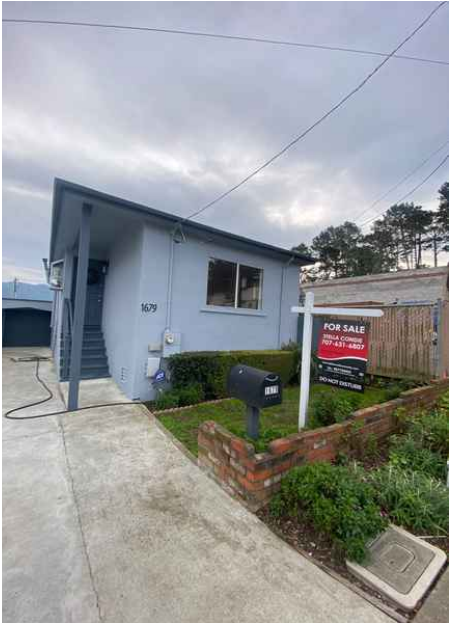
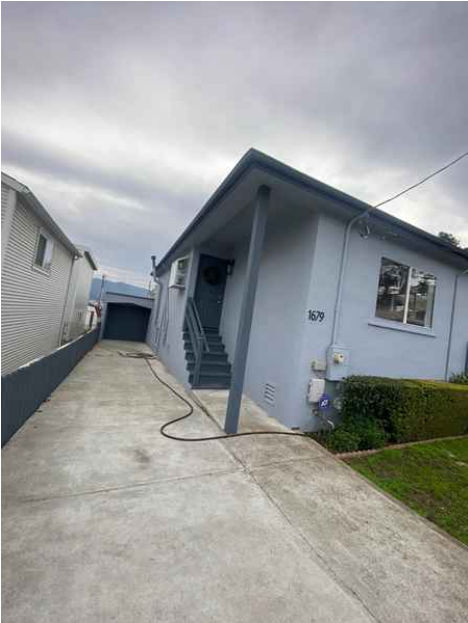
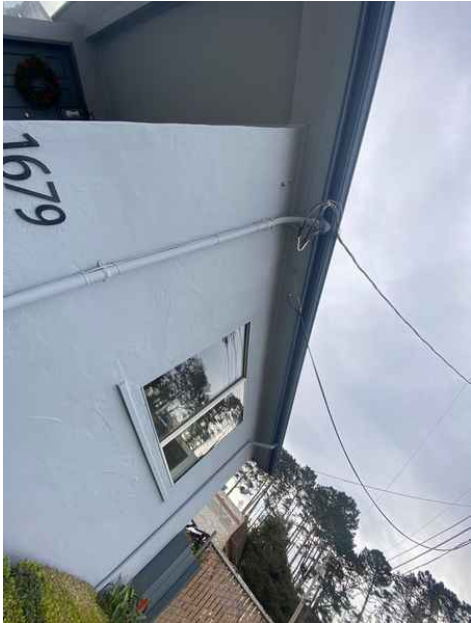
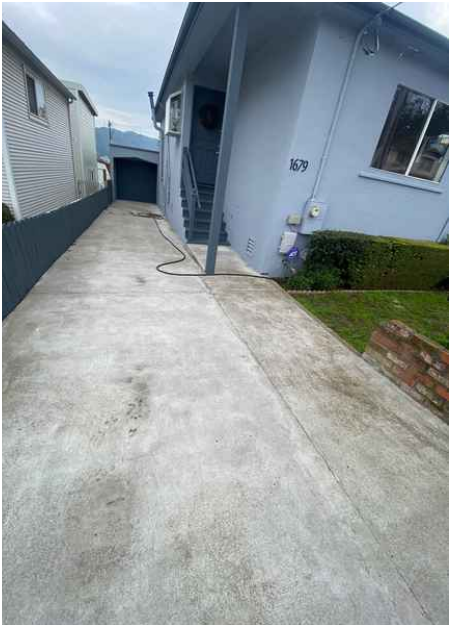
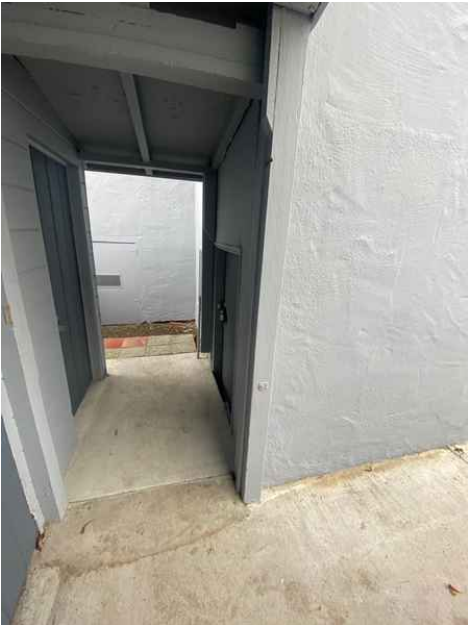
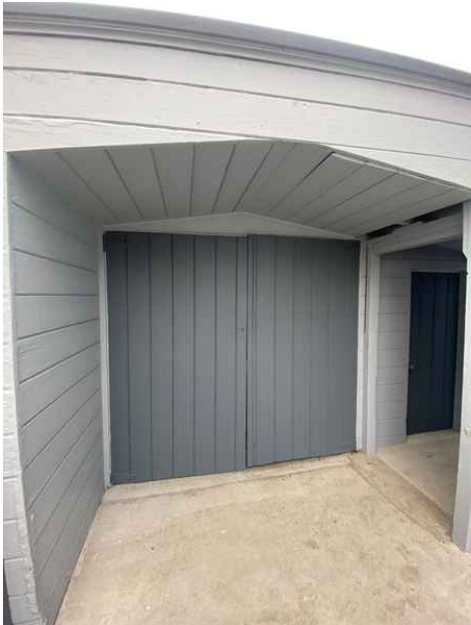
General: Exterior Was Inspected

I inspected the exterior of the house.

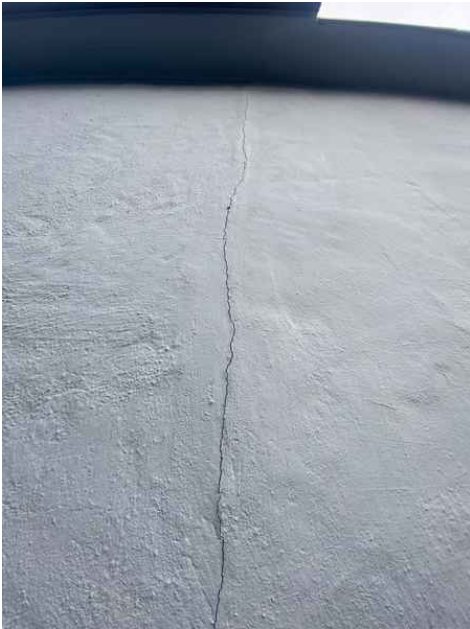
CRACKING - MAJOR

At the time of inspection observed major partial cracks adjacent to foundation entrance.

Contact a qualified structural engineer.

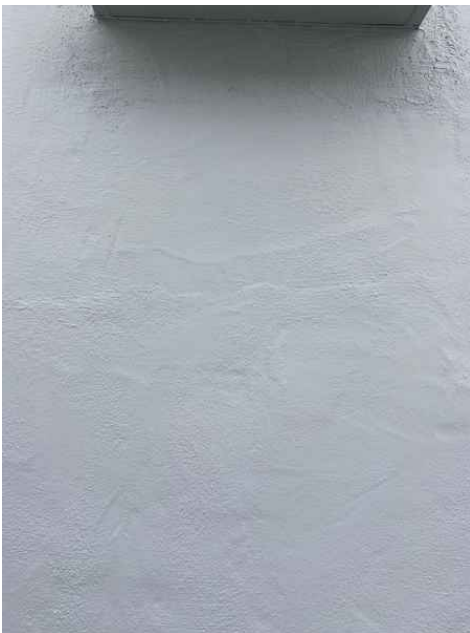
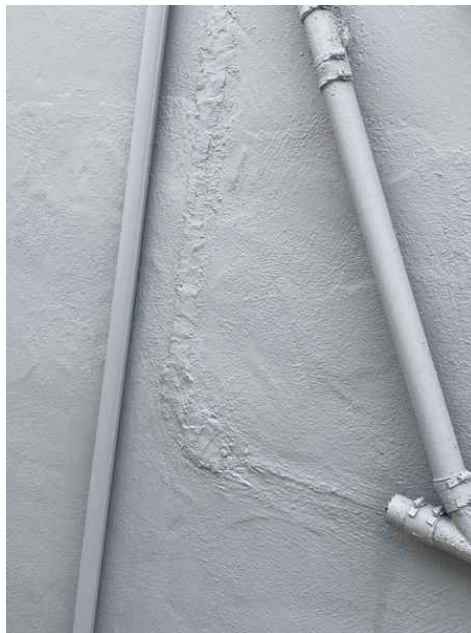
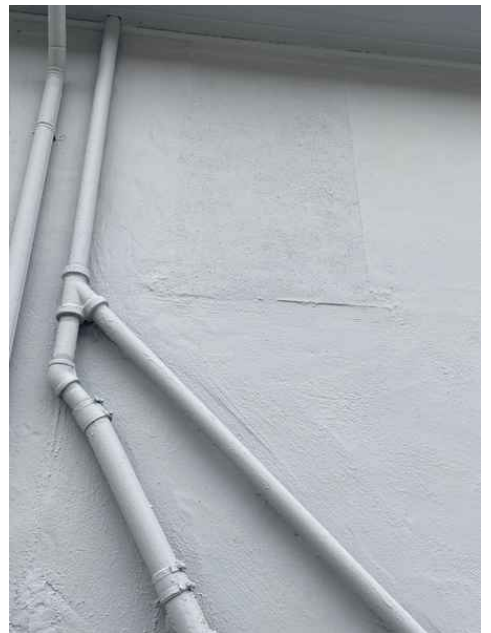
### 3.3.2 Wall-Covering, Flashing & Trim

#### **POOR PATCHING OBSERVED**

Please ask homeowner about possible repairs

Contact a qualified professional.

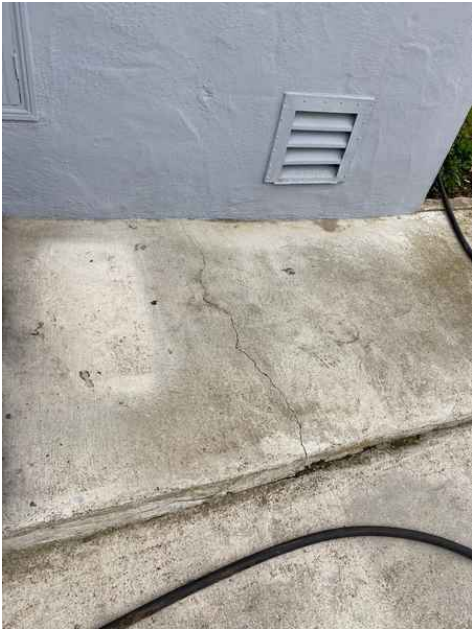
3.6.1 Walkways & Driveways

**MINOR CRACKING AT  
WALKWAY**

I observed minor cracking and no major damage at the walkway. Monitoring is recommended.

Contact a handyman or DIY project

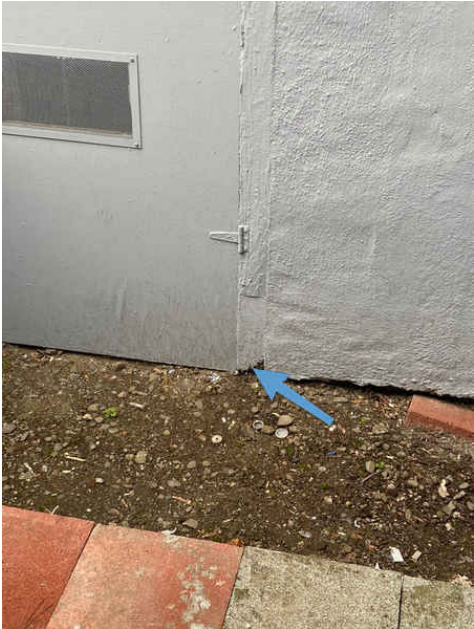
3.11.1 Exterior Doors

**WOOD ROT AT PATIO DOOR FRAME**

I observed wood rot at the exterior door.

Correction and further evaluation is recommended.

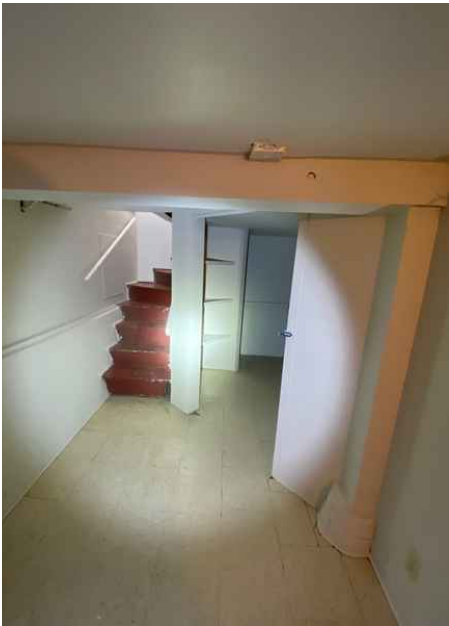
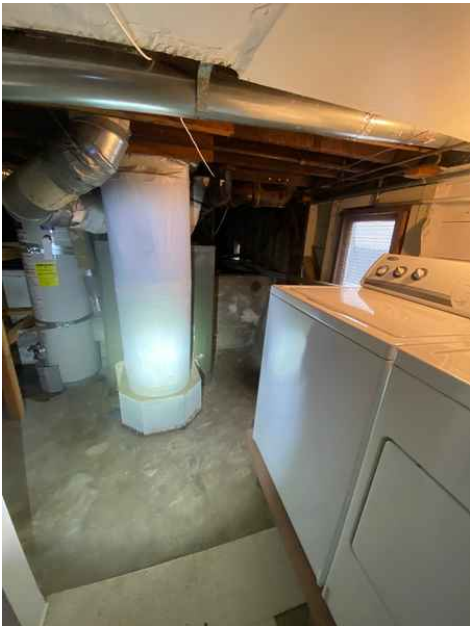
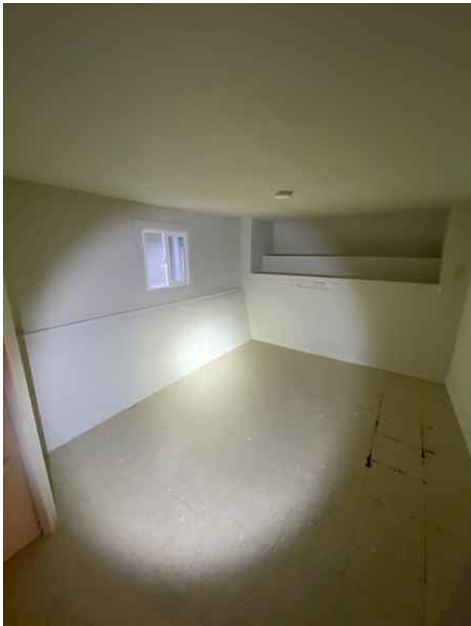
### Basement: Basement Was Inspected

The basement was inspected according to the [Home Inspection Standards of Practice](#). The basement can be a revealing area in the house and often provides a general picture of how the entire structure works. In most basements, the structure is exposed overhead, as are the HVAC distribution system, plumbing supply and DWV lines, and the electrical branch-circuit wiring. I inspected those systems and components. Inspection satisfactory.

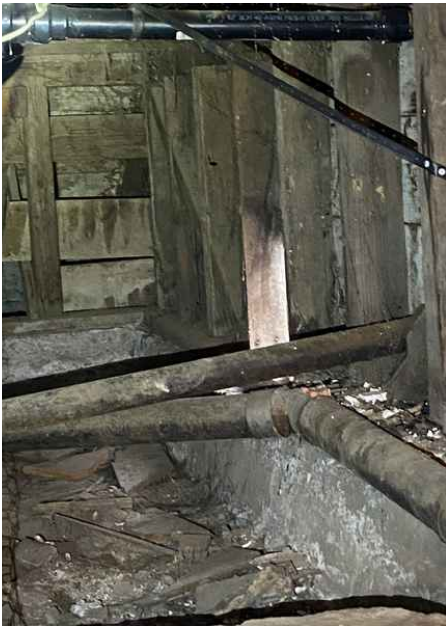
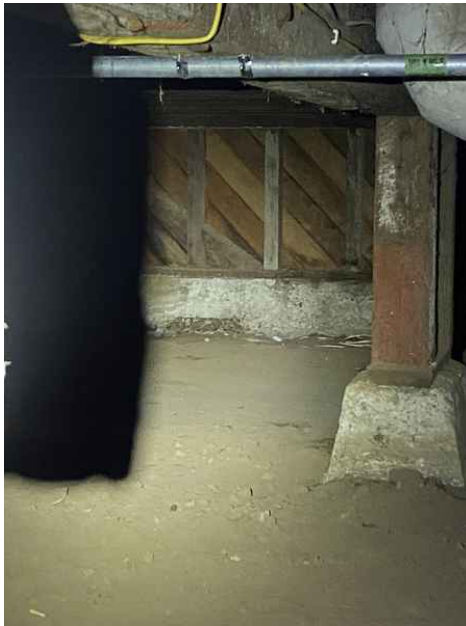
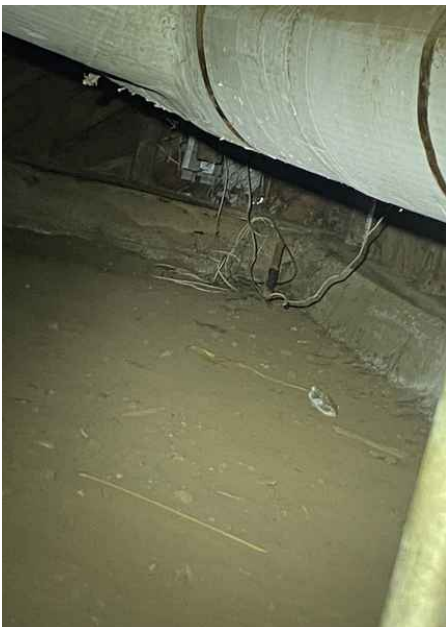
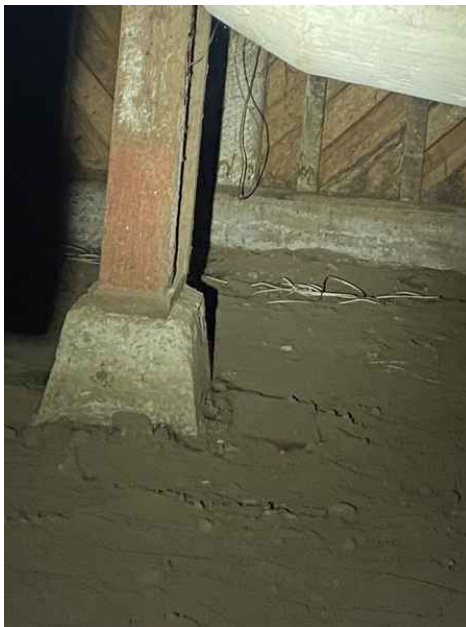
The under-floor crawlspace area was inspected according to the Home Inspection Standards of Practice.

The crawlspace can be a revealing area in the house and often provides a general picture of how the entire structure works. In many crawlspaces, the structure is exposed overhead, as are the HVAC distribution system, plumbing supply and DWV lines, and the electrical branch-circuit wiring. I inspected those systems and components.

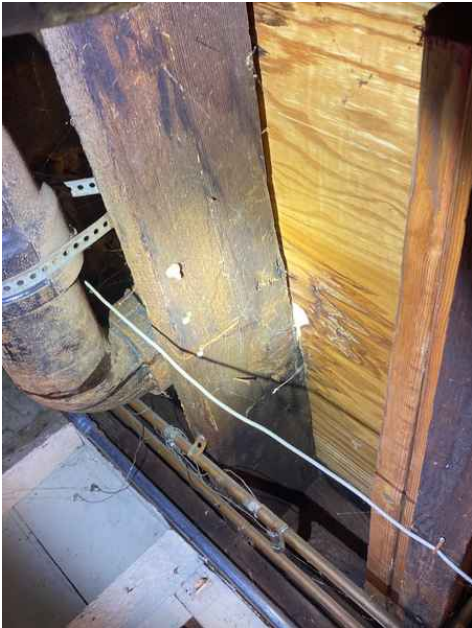
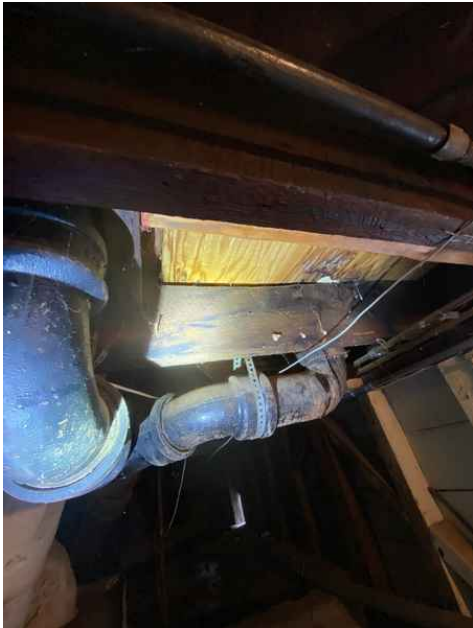
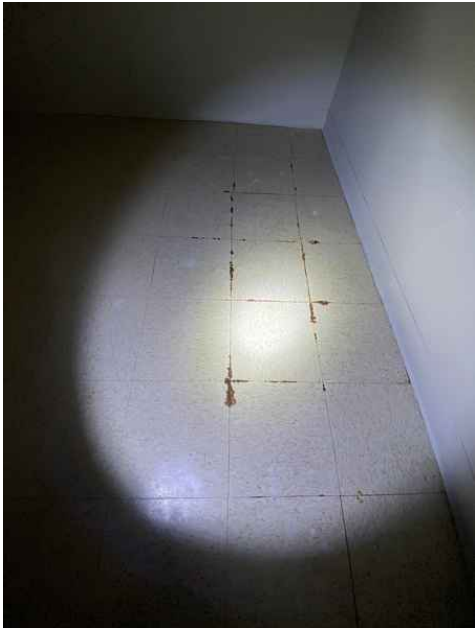
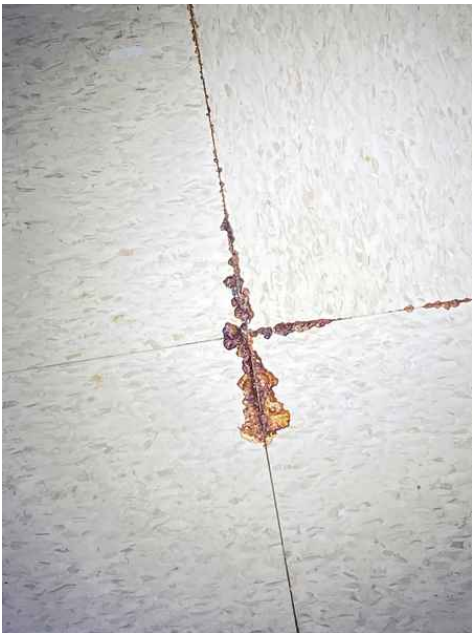
SIGNS OF OLD MOISTURE AND POSSIBLE MOLD FORMATION OBSERVED

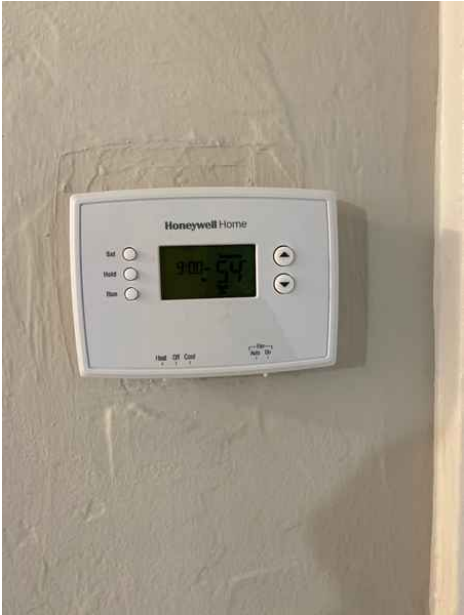
<b>Heating System Information:</b> <b>Energy Source</b> Gas, Electric	<b>Heating System Information:</b> <b>Heating Method</b> Warm-Air Heating System	<b>Thermostat and Normal Operating Controls:</b> <b>Thermostat Location</b> Hallway At the time of inspection, heating ,cooling tested satisfactory.
---	--	--

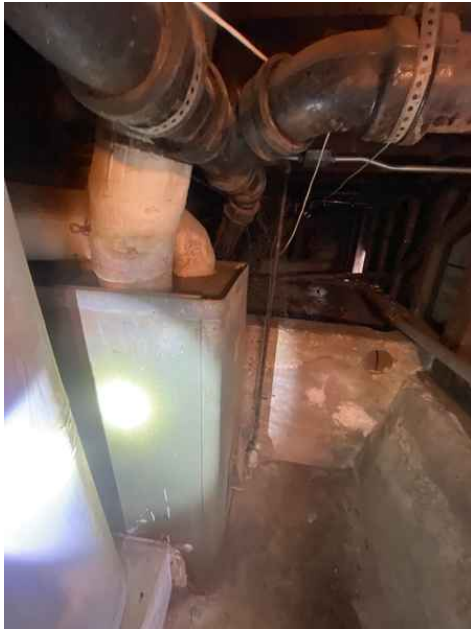
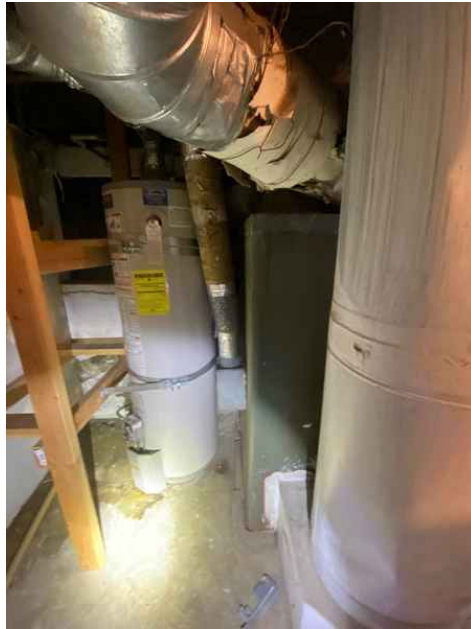
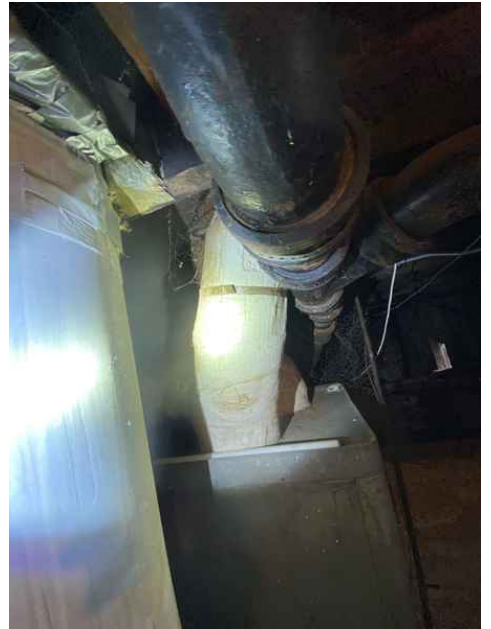
I observed during my inspection that the system appeared to be old and at the end of its service life. It may not be reliable. Ask the homeowner or occupant about its recent performance. Regular maintenance and monitoring of its condition is recommended. Budgeting for repairs and future replacement is recommended. [InterNACHI's Standard Estimate Life Expectancy Chart for Homes](#)

Recommend monitoring.

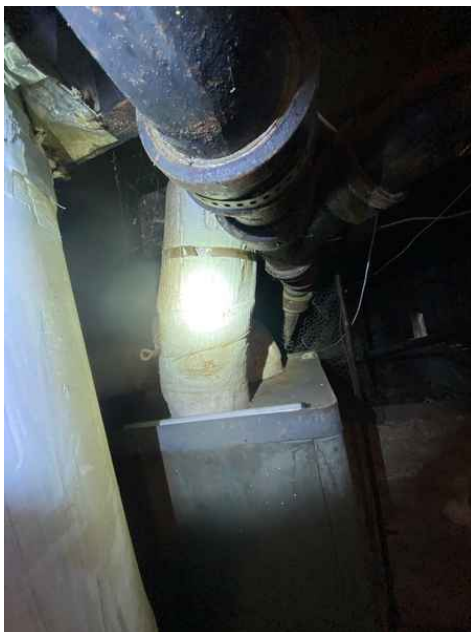
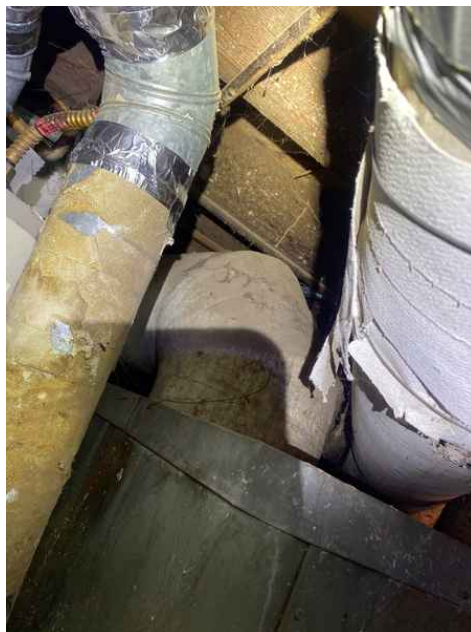
## 5.1.3 Heating System Information

**POSSIBLE PRESENCE OF ASBESTOS OBSERVED**

Contact a qualified professional.

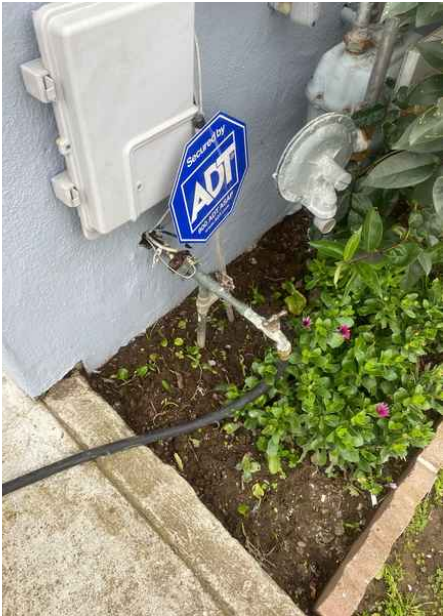
**Main Water Shut-Off Valve:**  
**Location of Main Shut-Off Valve**  
Outside of House

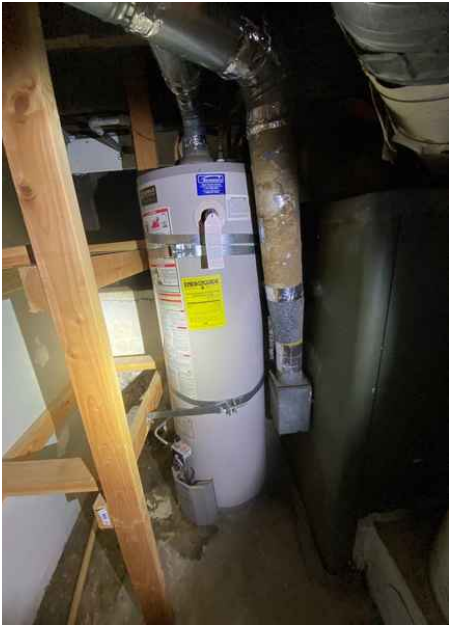
Gas-Fired Hot Water Tank

I inspected for the main source of the distributed hot water to the plumbing fixtures (sinks, tubs, showers). I recommend asking the homeowner for details about the hot water equipment and past performance.

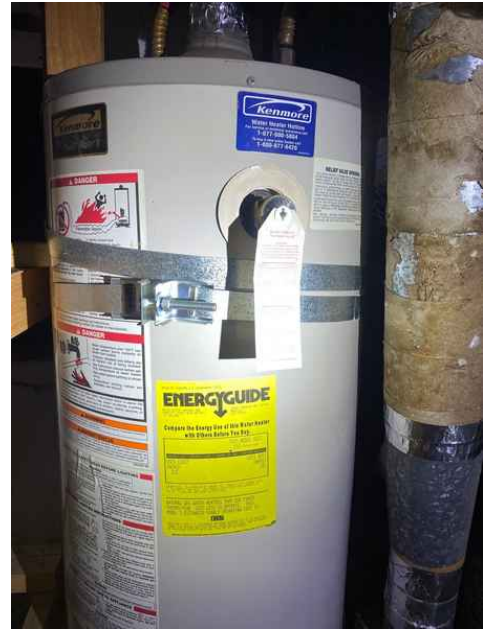
DEFECT AT TPR VALVE DISCHARGE

I observed a defect at the TPR (temperature, pressure, and relief) valve. The discharge pipe that serves a temperature pressure relief valve must:

- Not be connected to the drainage system.
- Discharge through an air gap located in the same room as the water heater.
- Not be smaller than the diameter of the outlet of the valve.
- Serve a single relief device.
- Discharge to the floor.
- Discharge in a manner that does not cause personal injury or structural damage.
- Discharge to a termination point that is readily observable.
- Not be trapped.
- Be installed so as to flow by gravity.
- Terminate no more than 6 inches above the floor or flood level rim of the waste receptor. And not less than 2 times the discharge pipe diameter.
- Not have valves or tee fittings.
- Be constructed of materials listed or rated for such use.
- Be one nominal size larger than the size of the relief valve outlet, where the relief valve discharge piping is installed with insert fittings.

Contact a qualified plumbing contractor.

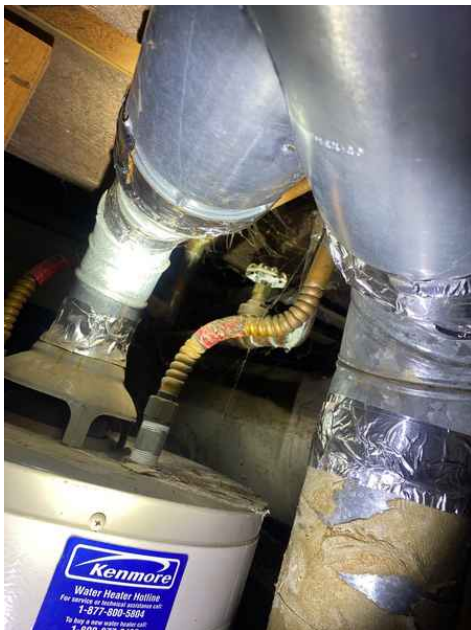
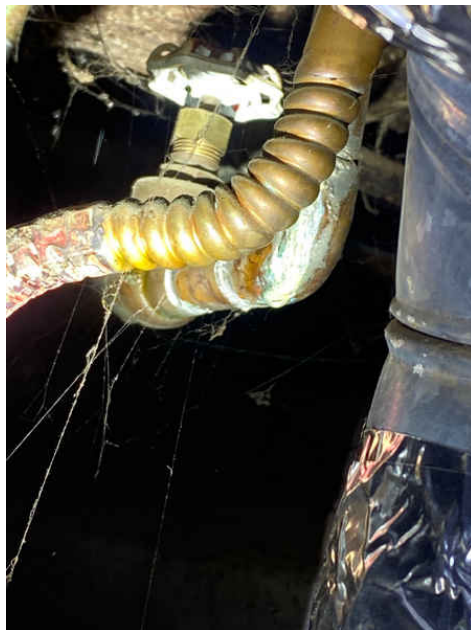
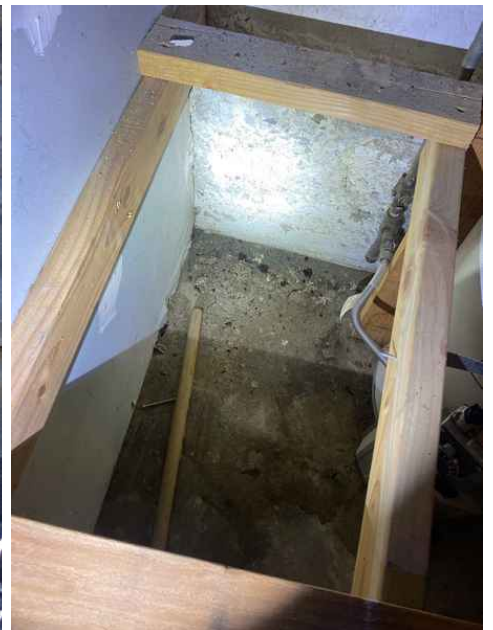
### **CORROSION AND WATER LEAK OBSERVED**

I observed corrosion at the hot water source.

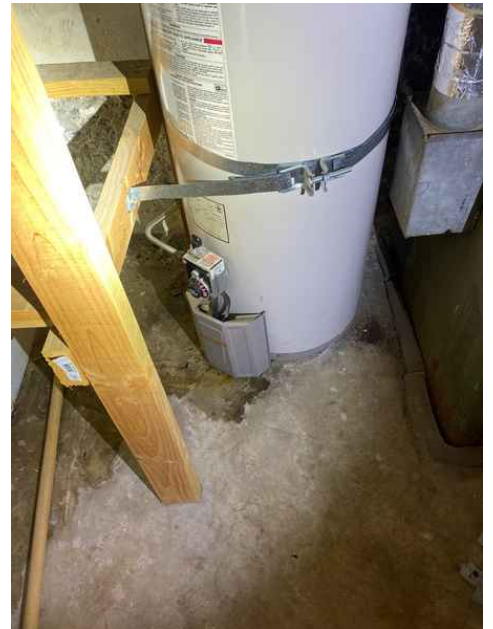
#### 6.3.3 Hot Water Source

### MISSING CATCH PAN UNDER TANK

I observed that the hot water tank is missing a water leak catch pan. Prone to wall damage.

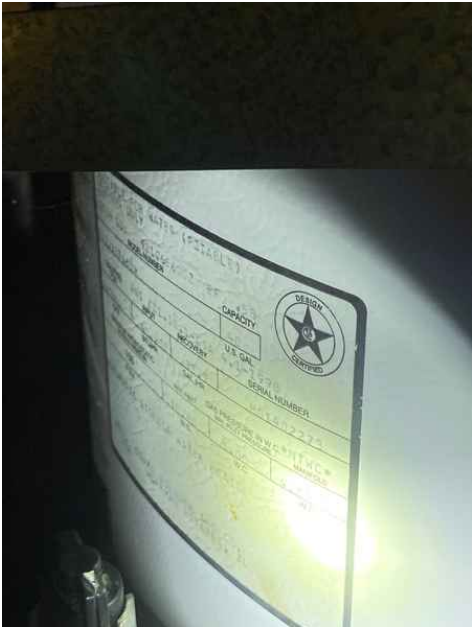
#### 6.3.4 Hot Water Source

### OLD SYSTEM (BUILT IN 1998)

Recommend monitoring.

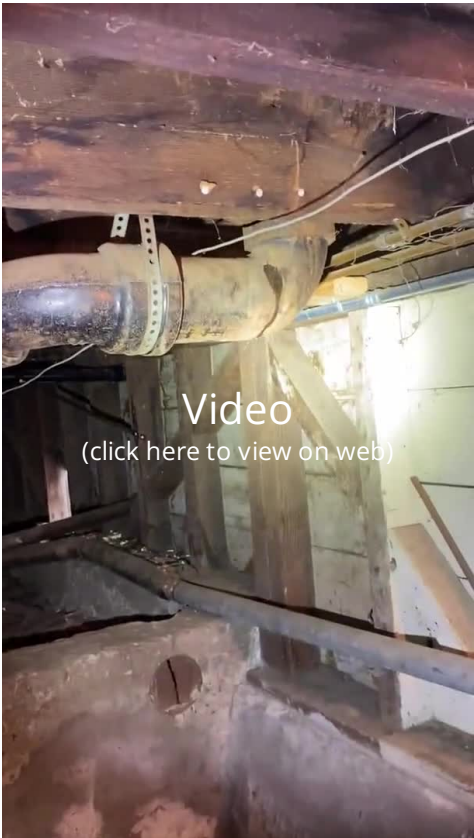
6.4.1 Drain, Waste, & Vent Systems

**ACTIVE LEAKING PIPE**

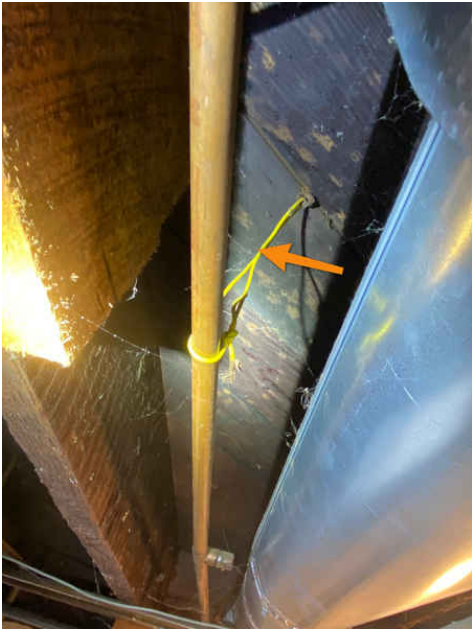
6.5.1 Water Supply & Distribution Systems

**POOR INSTALLATION**

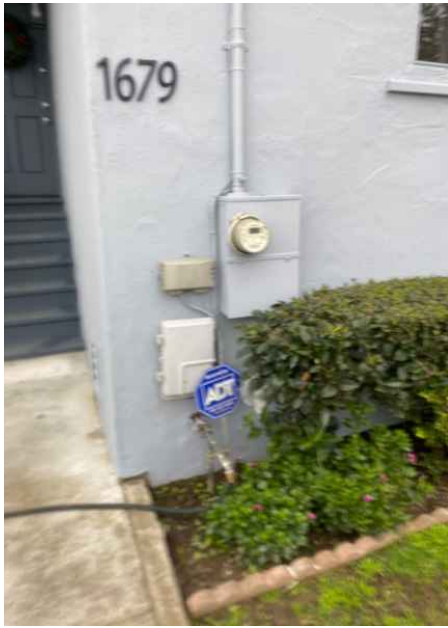
## Electric Meter & Base: Inspected the Electric Meter & Base

I inspected the electrical electric meter and base.

Inspection satisfactory.

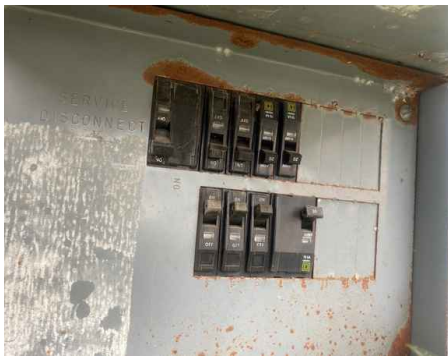
100

I observed indications of the main service disconnect's amperage rating. It was labeled.

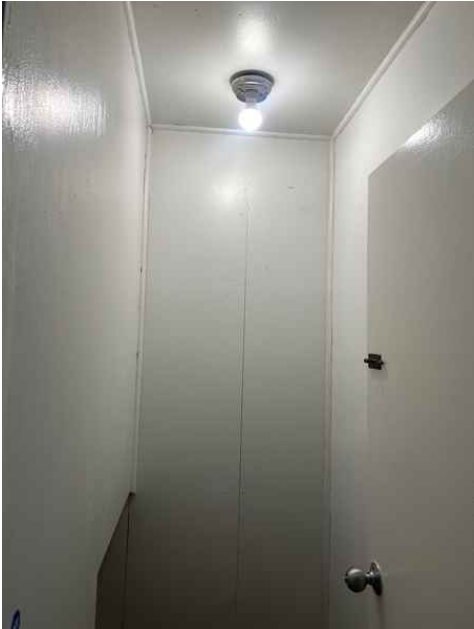
7.9.2 Electrical Defects

**BASEMENT LIGHT SWITCH NOT  
OPRERATING**

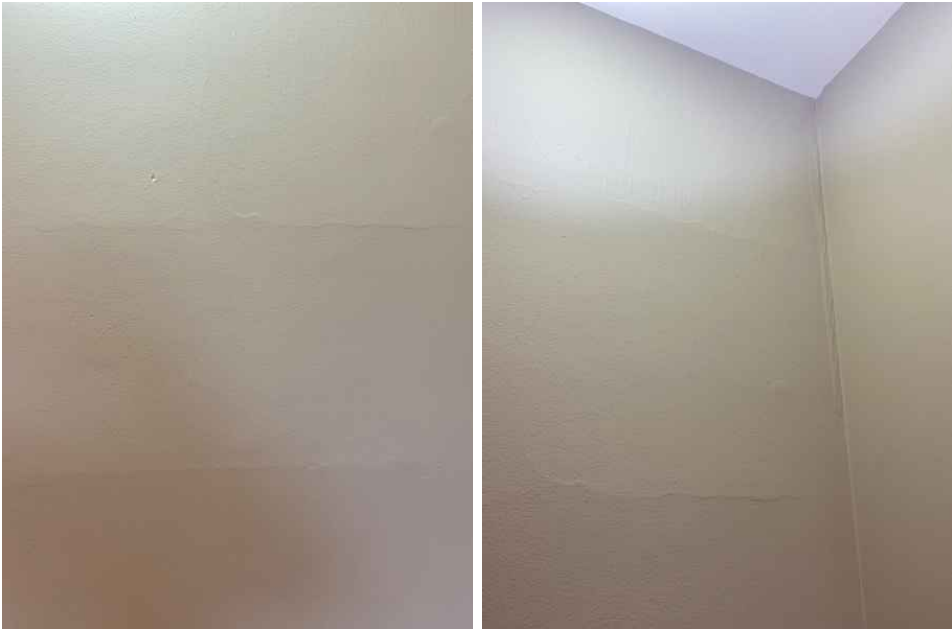
8.6.1 Ceilings

**POOR PATCHING**

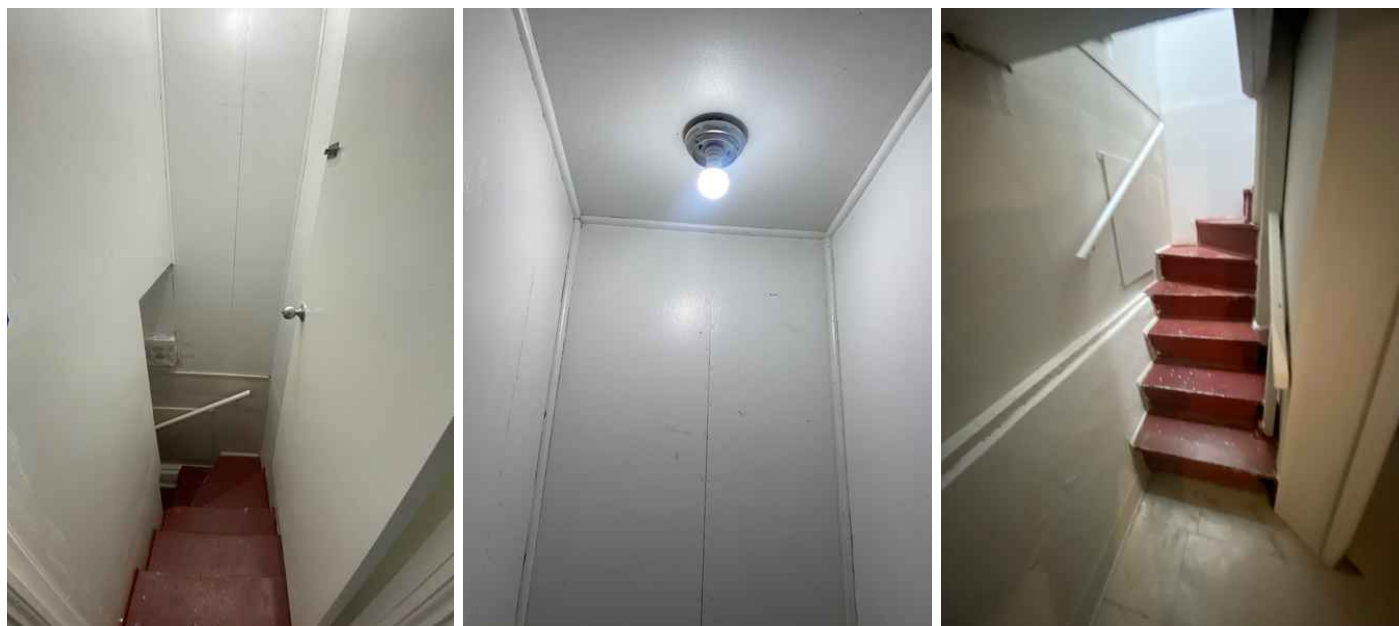
All treads should be level and secure. Riser heights and tread depths should be as uniform as possible. As a guide, stairs must have a maximum riser of 7-3/4 inches and a minimum tread of 10 inches.

Inspection satisfactory.

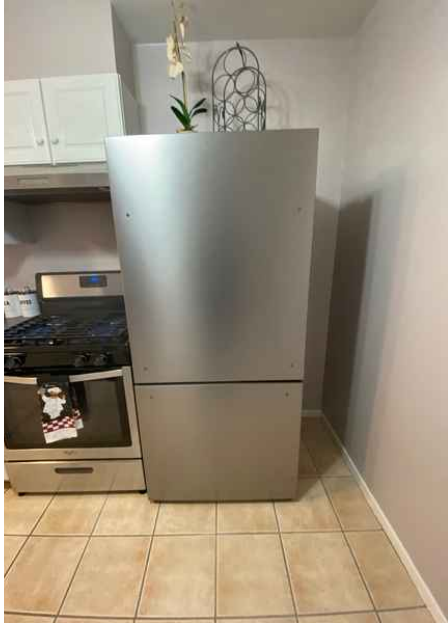
I checked to see if the refrigerator was on. It was. That's all I inspected in relation to a refrigerator. Refrigerators are beyond the scope of a home inspection.

Inspection satisfactory.

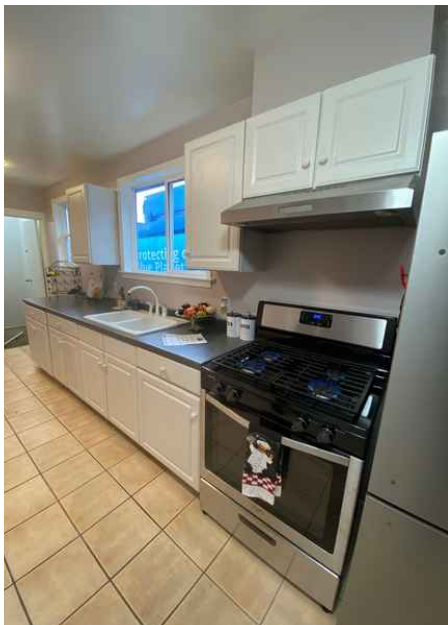
**Countertops & Cabinets: Inspected Cabinets & Countertops**

I inspected a representative number of cabinets and countertop surfaces.

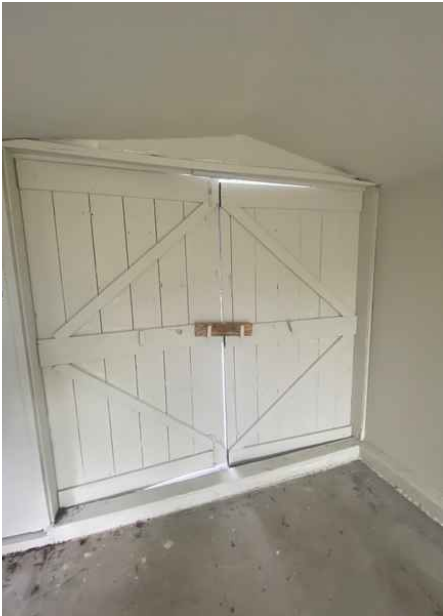
**Garage Vehicle Door: Type of Door Operation**  
Manual

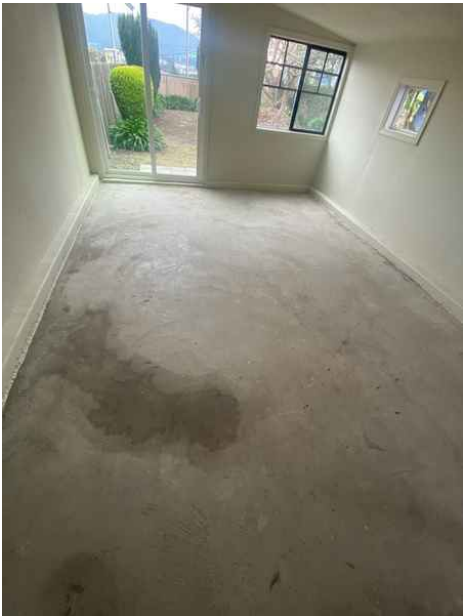
**Garage Floor: Garage Floor Inspected**  
I inspected the floor of the attached garage.  
Inspection satisfactory.

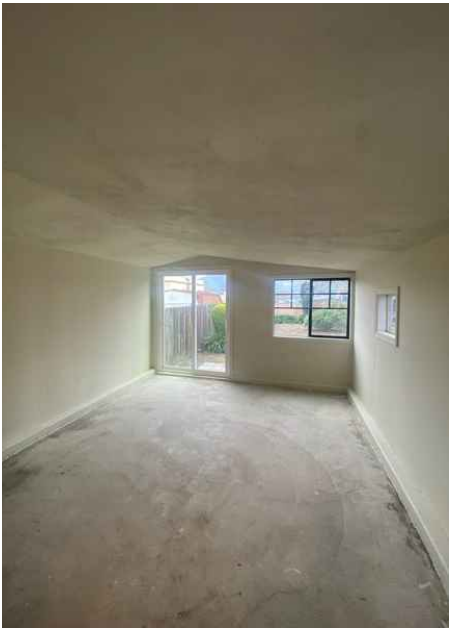
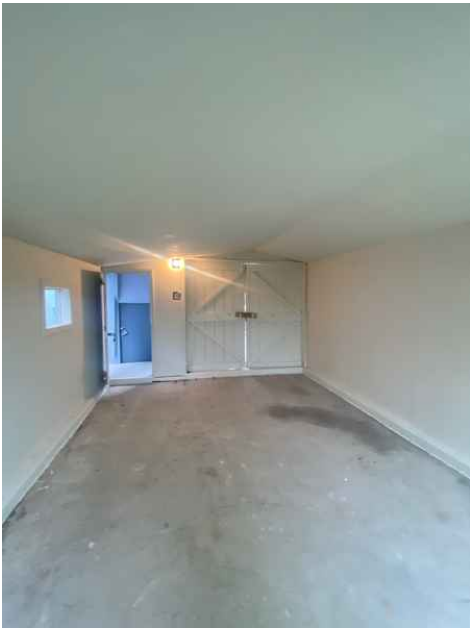
Ceiling, Walls & Firewalls in Garage: Garage Ceiling & Walls Were Inspected

I inspected the ceiling and walls of the garage according to the Home Inspection Standards of Practice.  
Observed unfinished or missing base boards .

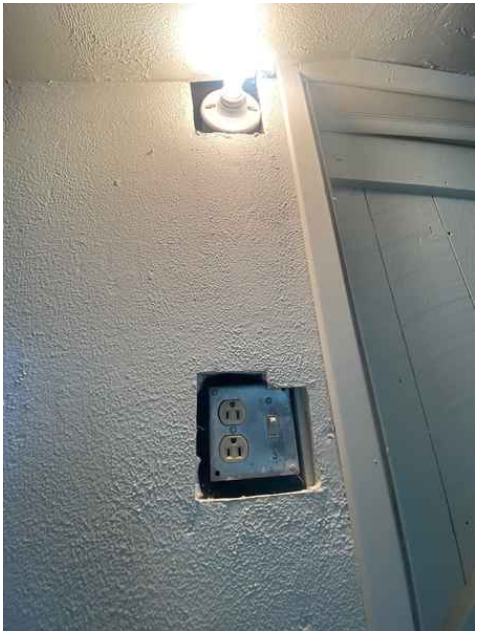
15.3.1 Electric in Garage  
**IMPROPER INSTALLATION**  
Recommendation  
Contact a qualified professional.

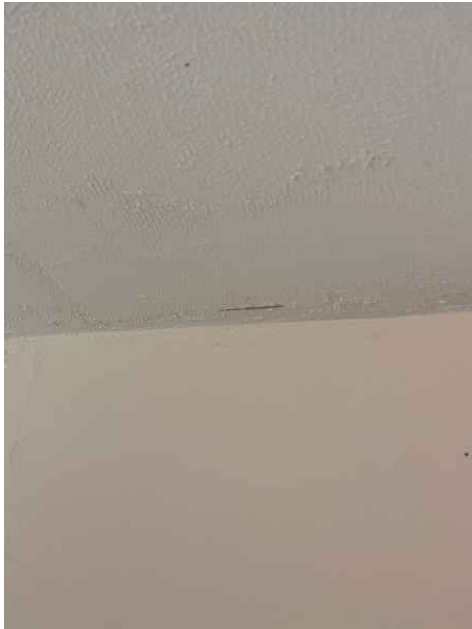
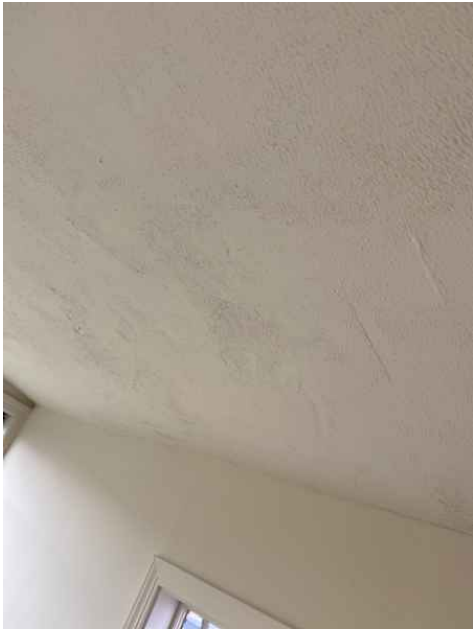
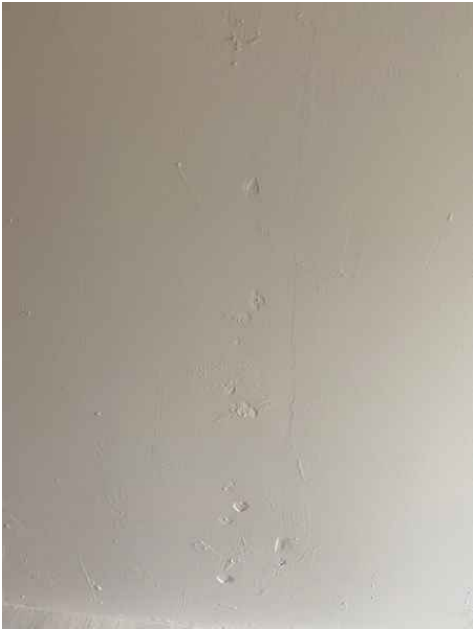
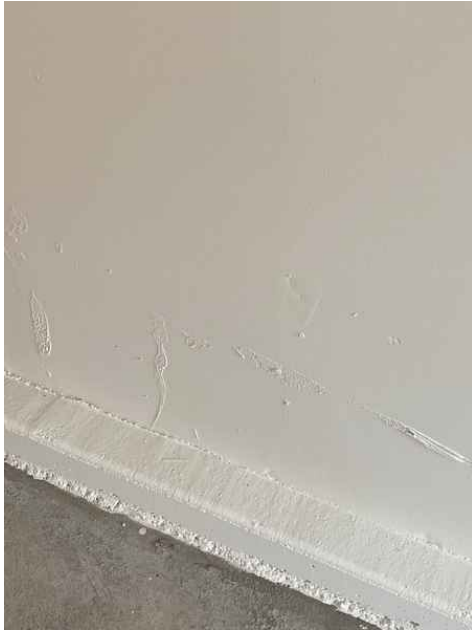
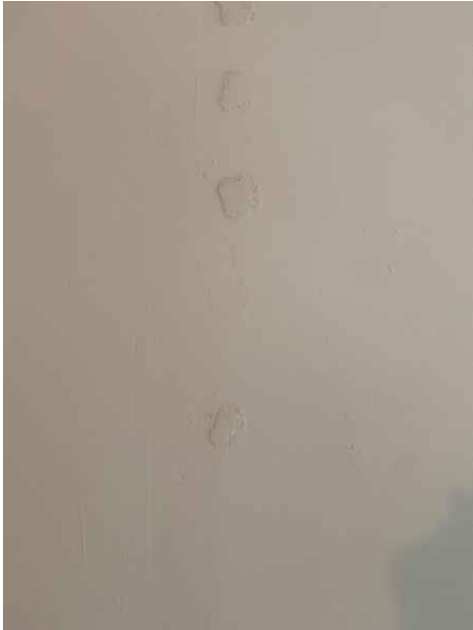
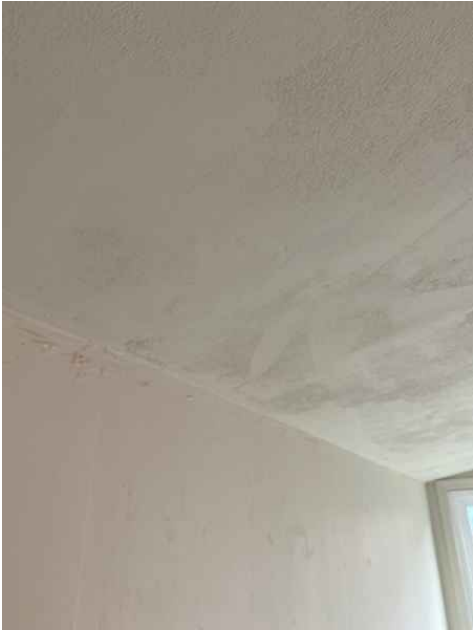
15.4.1 Ceiling, Walls & Firewalls in Garage  
**POOR PATCHING OBSERVED**  
Recommendation  
Contact a qualified professional.
